## International Plaza

### THE CHALLENGE

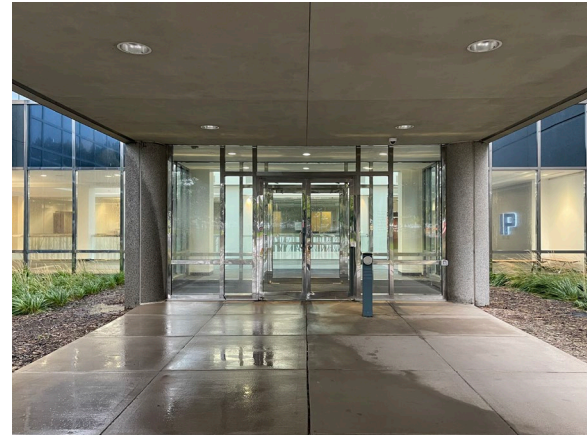
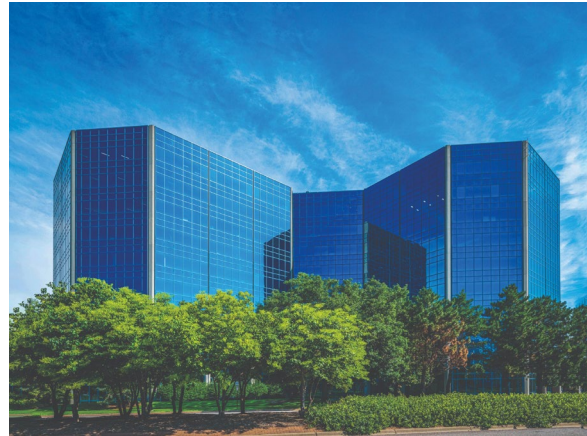
Both sets of main entrance doors were rubbing together which hindered the ADA door operations.

Our solution began with a thorough examination of the main entrance doors. We discovered that the pins, which help to hold the door in place and allow for smooth operation, were worn out and potentially misaligned, causing the doors to rub together. We removed the old, worn-out pins from the door hinges. The pins were then replaced with new ones that would provide better support to the doors. After this, we carefully adjusted all the doors to ensure they would no longer rub together when opening or closing.

The result of this solution was significant improvement in the functionality of the main entrance doors. They no longer rubbed together when being opened or closed, preventing damage and noise. The doors also operate smoother and safer, due to the proper alignment and the more robust support from the new pins.
